UNIVERSITY OF WISCONSIN SEA GRANT INSTITUTE

Failing Coastal Wood Infrastructure on the Great Lakes

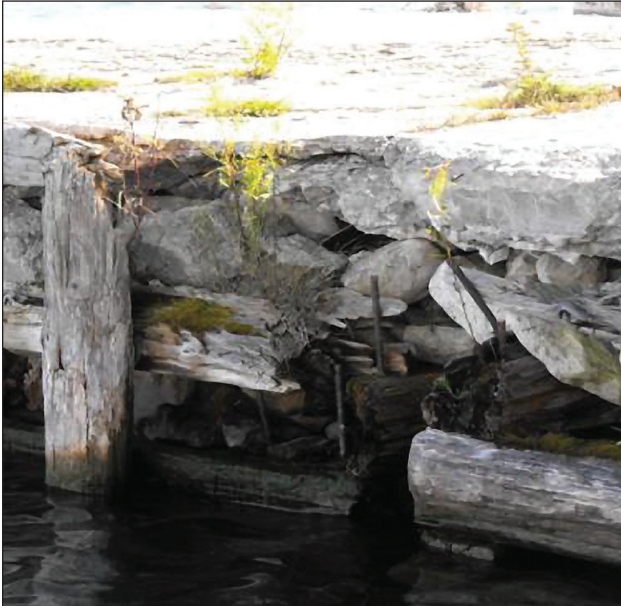
Timber pilings will also rot when exposed to constant cycles of wet and dry. Figure 4 shows a timber crib wall with significant rot, and Figure 5 shows timber pilings rotting near the water surface. Once the timber begins to rot, the stone filling the crib- or pile-supported structure can spill out and disperse into the lake alongside the structure. Figure 6 shows an example of the loss of interior stone from an underwater timber crib.

Figure 4: Timber structure rot (Gene Clark/UW Sea Grant Institute).

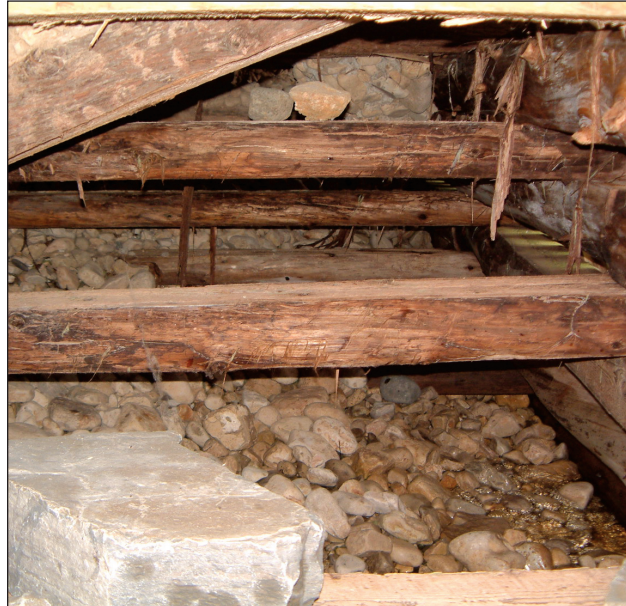
Figure 6: Timber crib with interior rock loss (Bill Brose-SmithGroupJJR).

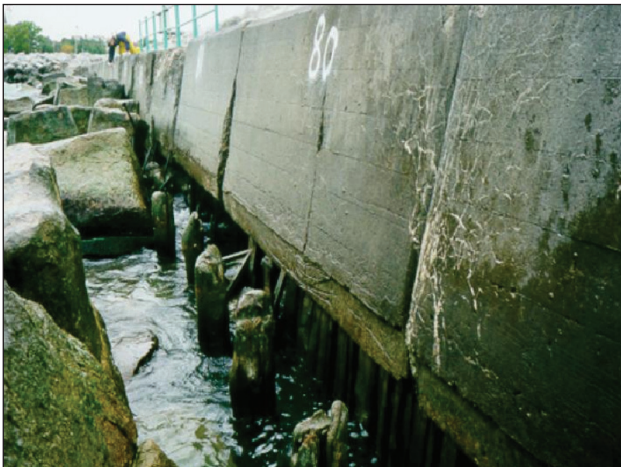
Figure 5: Timber piling rotting at the water surface (Larry Ryan-Baird).

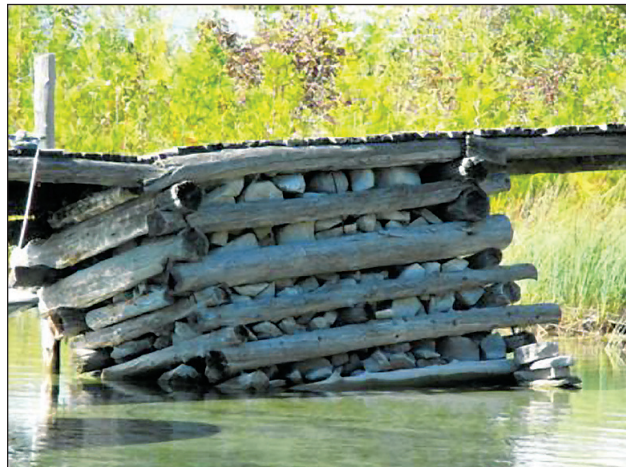
Poorly designed timber crib foundations have also caused structure failure. Wave action at the base of these structures scours the foundation material away, causing the timber crib to settle. This scour can also be due to low water conditions with additional ship thruster action contributing to structural deterioration. Figure 7 shows a timber crib section that has failed due to a poor foundation.

Figure 7: Timber crib settlement failure (Gene Clark/UW Sea Grant Institute).

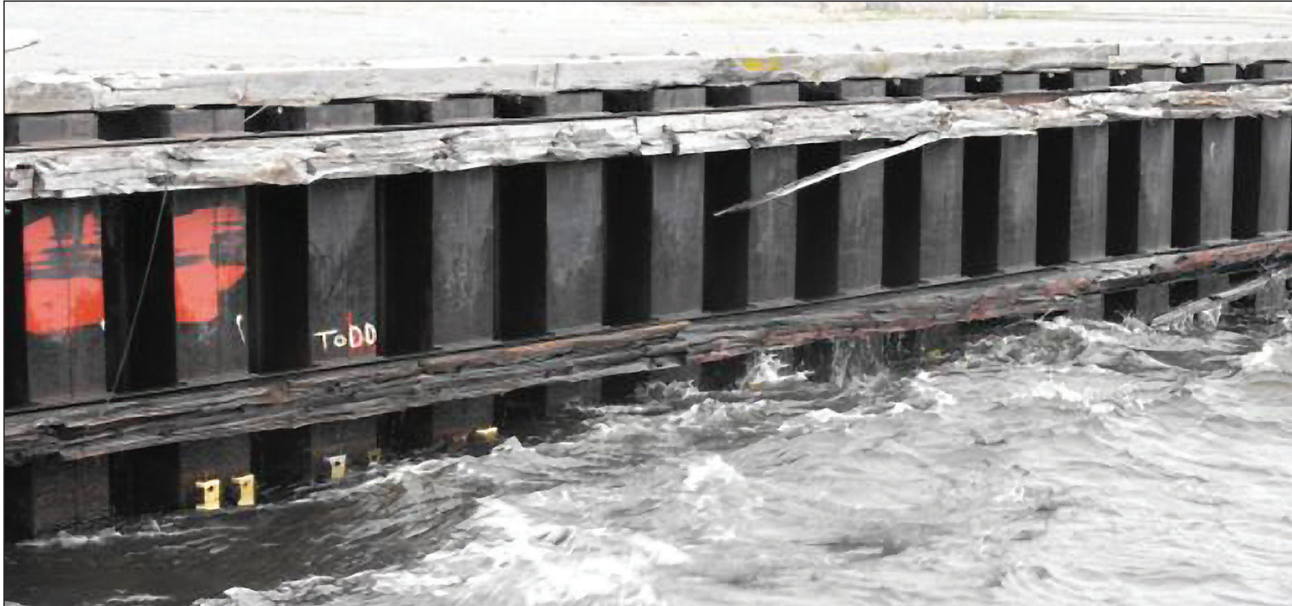
Timber wear or abrasion due to ice or ship damage are other common conditions that can lead to timber failure. While this type of failure does not often compromise the structure behind the timber, it can cause significant damage to the vessel attempting to moor alongside the vertical face of the structure. Figure 8 shows abrasion damage to a timber abrasion protection section.

Figure 8: Timber ice abrasion damage (Gene Clark/UW Sea Grant Institute).

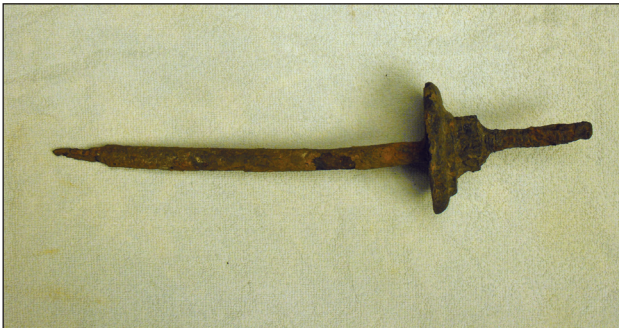
Sea Grant fact sheet “Accelerated Freshwater Harbor Corrosion,” which is available in the Aquatic Sciences online publication store at <http://aqua.wisc.edu/publications/PDFs/FreshwaterHarborCorrosion.pdf>.) Once these steel pins corrode, the timber cribs start to come apart and fail similarly to those with rot issues. Figure 9 shows a corroded steel pin. Note that steel remains where the pin would be in the timber, but it is corroded where the pin would exit the crib and cross the open stone-filled interior of the crib.

Figure 9: Corroded timber crib connection steel pin (Gene Clark/UW Sea Grant Institute).

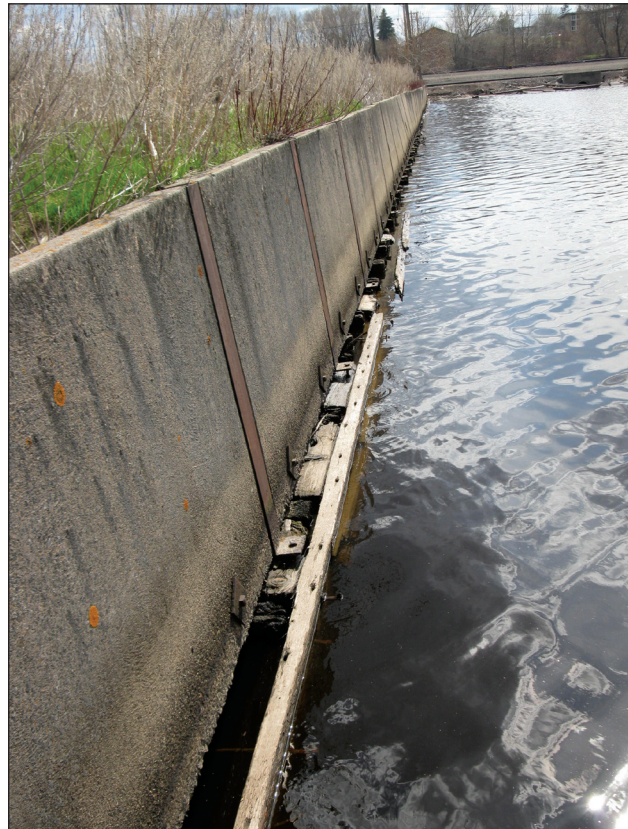
Figure 10: New wall constructed on top of failed timber crib (Chad Scott-AMI Consulting Engineers).

When the timber deterioration is near the water surface, the failed timber can be removed and a new structure attached to the remaining crib top near the water level. This structure could be a new timber crib or steel H-beams attached to the existing crib, with either new timber beams or precast concrete panels placed between the vertical beams (soldier pile walls). See Figure 10 for an example of a new concrete wall constructed on top of a failed timber crib.

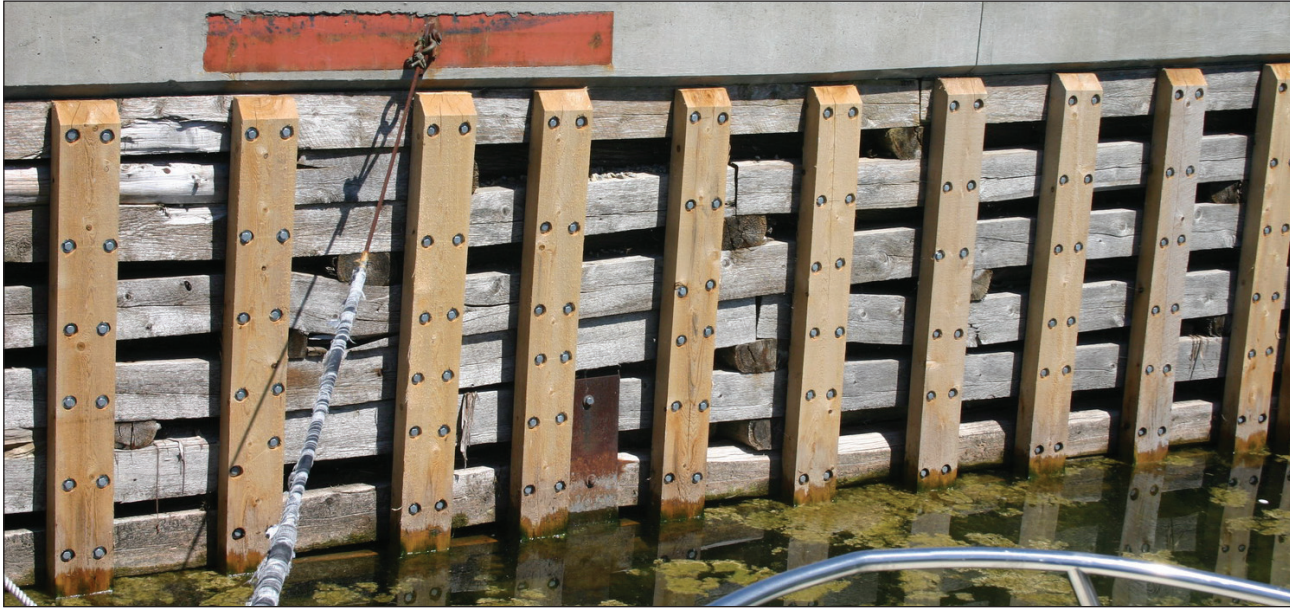
Figure 11: A failed timber reinforcement section (Larry Ryan-Baird).

If the timber has only slightly deteriorated, the existing timber can be reinforced with new timber members if easy access is possible and there is no danger to the remaining section. Figure 11 shows vertical reinforcing added to an existing timber crib.

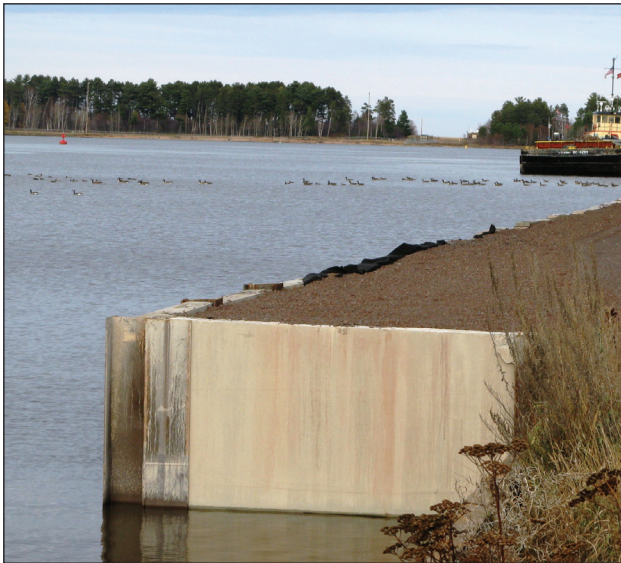
Figure 12: A new wall in front of a failed timber structure (Chad Scott-AMI Consulting Engineers).

on the type of structure. Options include a complete new facing that consists of a steel H-piling driven in front of the failing crib or wood wall from the lake bottom to above the existing surface with timber beams or precast concrete panels. The front facing could also be constructed of steel sheet pile with a fill of stone between the old and new structure. Figure 12 shows a new steel and concrete wall built in front of a failing timber structure.

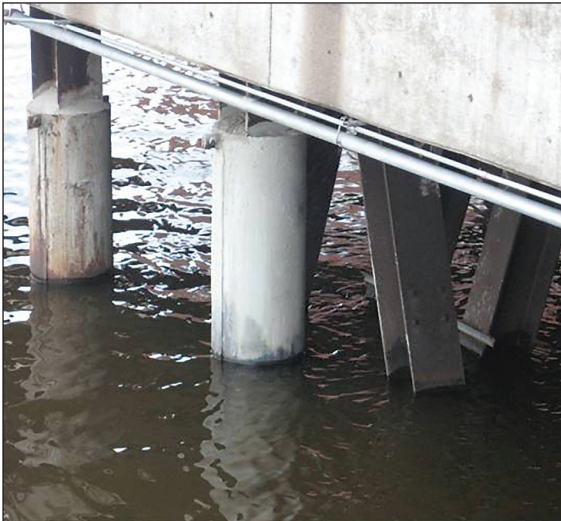
Figure 13: Steel jacket option shown on steel pile (Gene Clark/UW Sea Grant Institute).

Wood pilings that have not rotted too severely could be encapsulated with jackets—for example, using steel pipe halves bolted together around the damaged sections, fiberglass shells filled with either a concrete or epoxy grout, or high-density polyethylene wraps. See Figures 13, 14 and 15 for examples of jackets used on steel H- and pipe-piles. They are representative of timber piling protection as well.

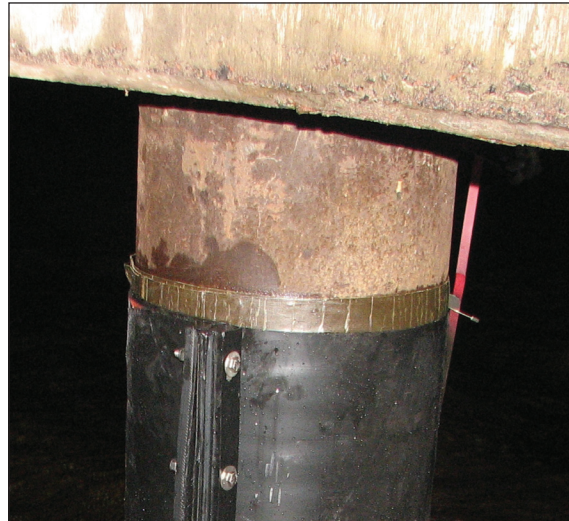
Figure 15: High-density polyethylene jacket option shown on steel pile (Gene Clark/UW Sea Grant Institute)

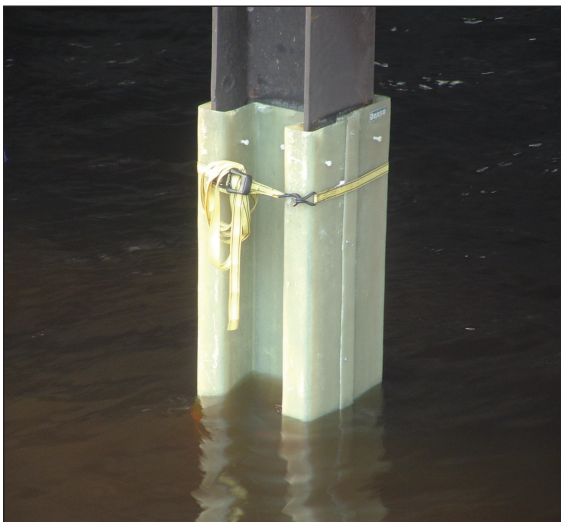
Figure 14: Fiberglass jacket option shown on steel H-pile (Gene Clark/UW Sea Grant Institute).
