UNIVERSITY OF WISCONSIN SEA GRANT INSTITUTE

Great Lakes Accelerated Freshwater Harbor Corrosion

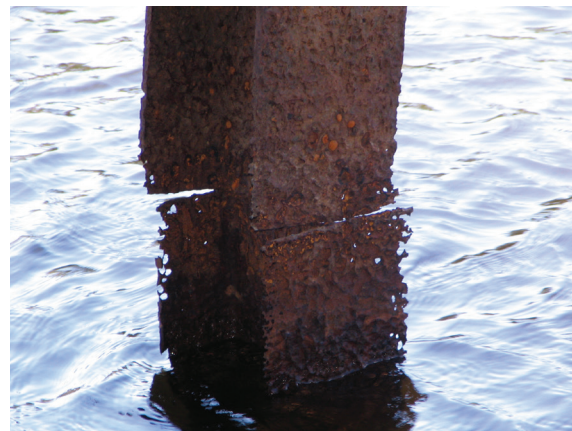
Steel H-pile corroded completely through (left) and Murphy oil dock (right)

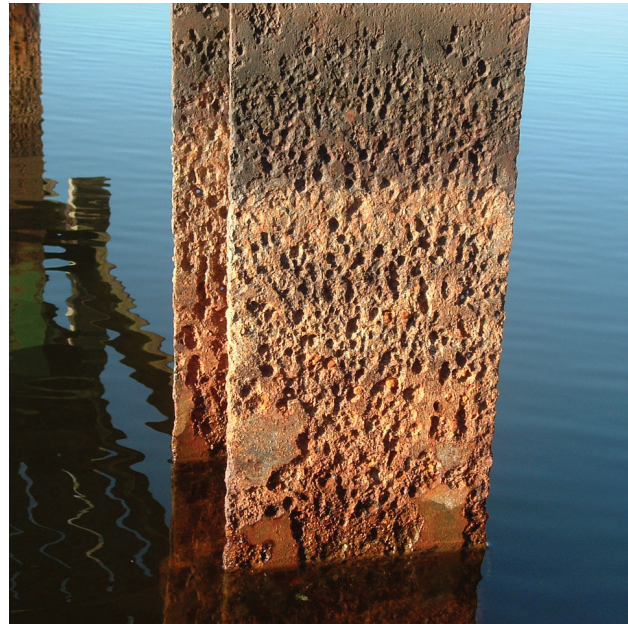
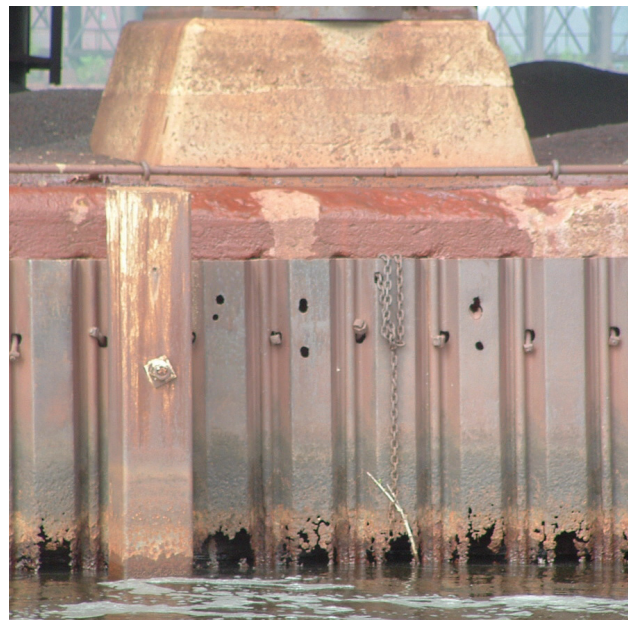
Widespread corrosion at Hancock, Michigan, (above) and Canadian National docks, Duluth, Minnesota (below)

Underwater inspections have revealed the corrosion is widespread throughout the Duluth-Superior Harbor on all types of steel piling. Most of the steel is covered with small pits, scooped out in diameters of ¼ to 1 inch, primarily in the first 3 to 6 feet below the waterline and tapering off around 10 feet. For most structures there is only minor or insignificant corrosion loss deeper than 10 feet, all the way down to the mud line. Some of the steel dock structures have holes as large as 6 to 12 inches or more, and several of these structures have already been or are in the process of being repaired or replaced.

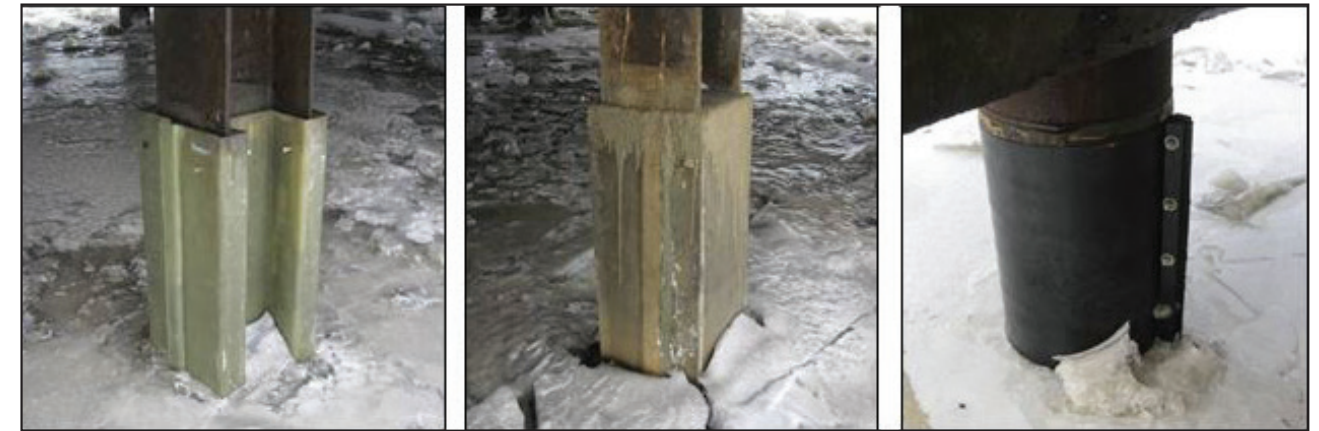
Pile test protection methods
