UNIVERSITY OF WISCONSIN SEA GRANT INSTITUTE

Great Lakes Accelerated Freshwater Harbor Corrosion

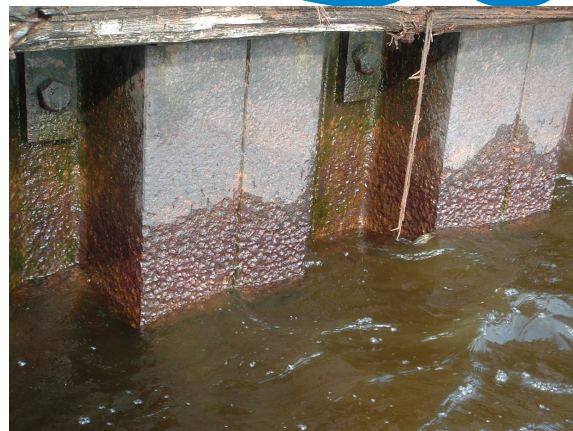
Steel H-pile corroded completely through (left) and Murphy oil dock (right)
