UNIVERSITY OF WISCONSIN SEA GRANT INSTITUTE

Best-Practice Inspection Guidelines for Great Lakes Port, Harbor and Marina Structures

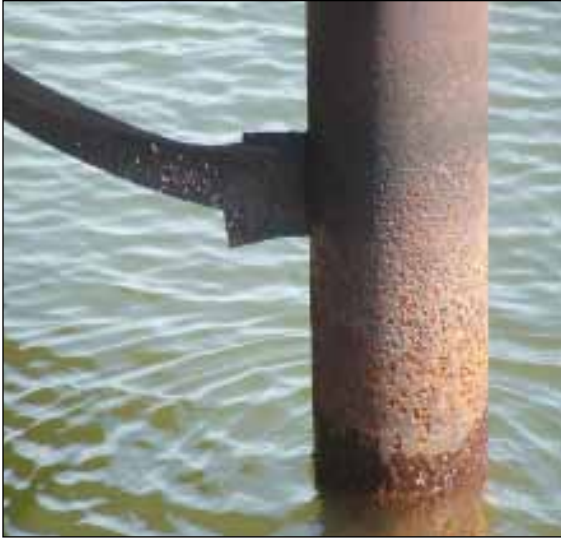
Figure 1: Steel Corrosion on Lake Superior.

damage and pitting of the metal. See Figure 1 for an example above-water steel observation.

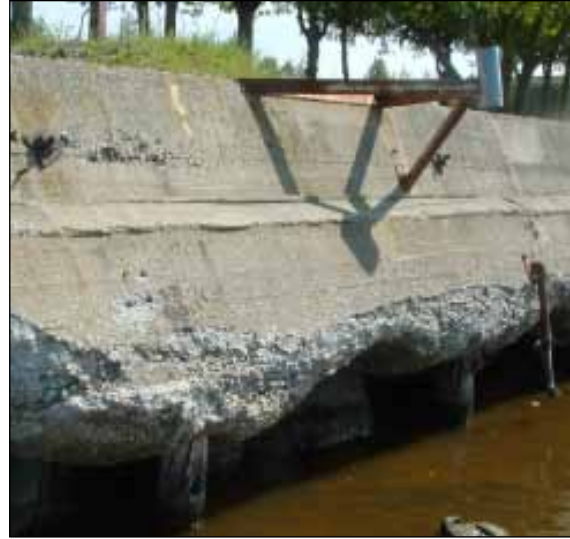
Figure 2: Concrete Structure Problems on Lake Michigan.

For concrete structures, personnel should look for cracking, efflorescence/exudation and leaching (white deposit caused by moisture leaching through the concrete), scaling, delamination, spalling and/or signs of exposed rebar. See Figure 2 for an example of above-water concrete observation.

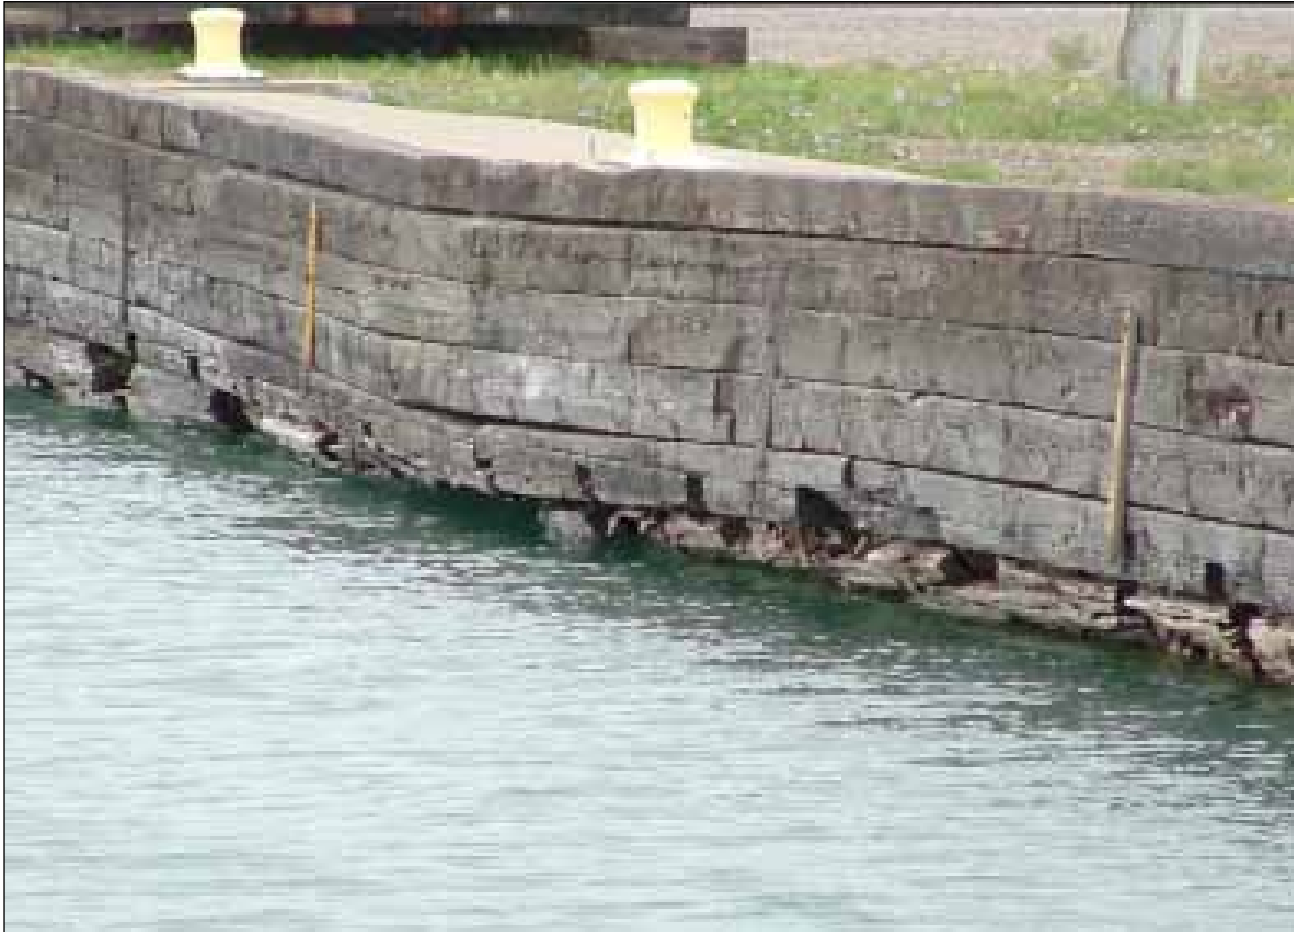
Figure 3: Timber Bulkhead Wall Failure on Lake Superior.

For timber structures, personnel should look for evidence of insect damage, rot/ fungus, checking, cracking or splitting, impact damage, connecting hardware problems, or broken pieces. Refer to Figure 3 for an example of damaged timber structure.

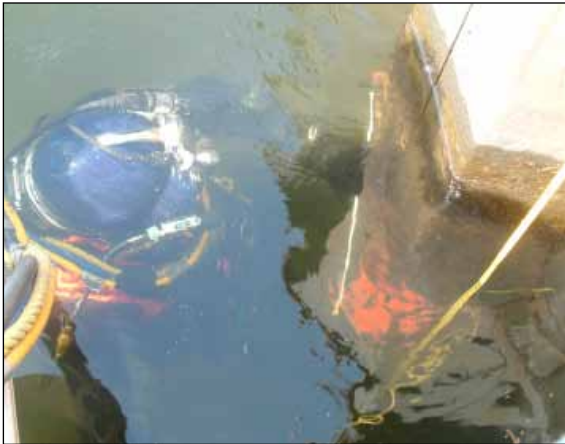
Figure 4: Typical Diver Inspection of Steel Bulkhead Wall.

For underwater inspections, it is best practice to use ADCI certified commercial engineer-diver teams experienced in Great Lakes underwater inspections. Typically, the underwater inspections can be divided into three levels of inspection (Levels I, II, and III). Divers often photograph and videotape observed defects for further analysis and comparisons to earlier inspections. See Figure 4 for a picture on an inspection diver complete with attached camera to his helmet.
